**Re: Dangerous Waste Compliance Inspection on January 21, 2015 at McFarland Cascade,
aka Stella-Jones, RCRA Site ID: WAD053823019**

RCRA Site ID: WAD053823019	Facility Name: McFarland Cascade/Stella-Jones	Inspection Date: January 20, 2015
Generator Status: LQG	Facility Address: 6520 188th St NE, Arlington WA 98223	Date Report Sent: March 11, 2015

Inspection Report

PHOTO LOG

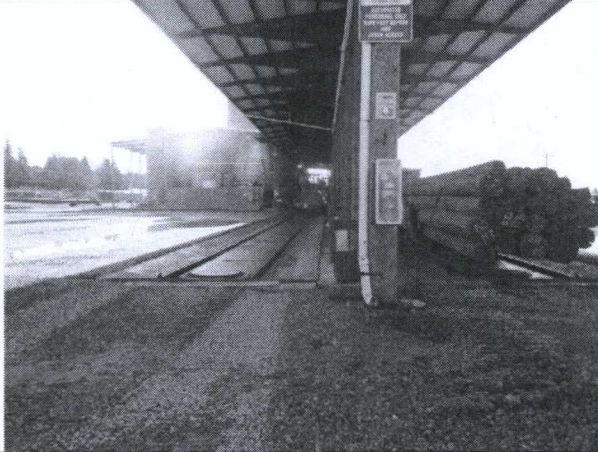
Walk-through of the retort area included visual inspection of the new steel drip pad surfaces for retorts 2 and 3 (Photos 1 & 2). Plans for upgrades were not submitted to this department prior to work being done. This is noted as a violation above (WAC 173-303-675(2)(b)). No treated logs were on the eastern most drip pad (retort 2), but a charge was on the retort 3 drip pad at the time of our inspection. Mr. Hillery stated that the drip pads had been refurbished in 2014. Mr. Hillery mentioned that the old pads were the same shape as the new ones, but concrete. Tracks were pulled up and replaced. The inspection ports located at the north end of each pad were sealed with steel during the renovation. All drips from treated poles run into collection pans located at the north end of each retort (Photo 6). Mr. Hillery said that debris on the pads is swept up and collected in a satellite drum located near retort 2. We observed this drum at the north end of the building's catwalk. This drum is under the roof of the building with secondary containment provided by the cement containment which surrounds all tanks within the building. The 55-gallon metal drum was properly

Area & Description	Photographs
<p>#1 Drip Pad Area</p> <p>Newly constructed steel drip pads (12/15/14) located at north end of retorts 2 and 3.</p>

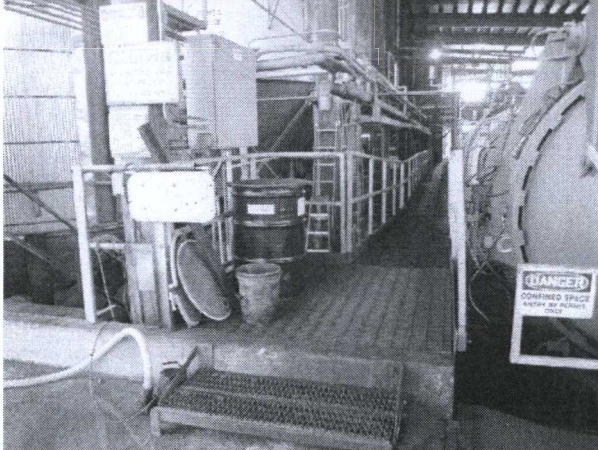
A black and white close-up photograph of a drip pad. A finished charge of poles is sitting on the drip pad. The poles are stacked and appear to be made of wood or a similar material. The drip pad is made of metal and is situated under a large, open-sided structure.
<p>#3 Retort Area</p> <p>North end of retort. Picture shows satellite 55-gallon drum containing F001, D001 waste solids and empty blue pail adjacent to drum.</p>

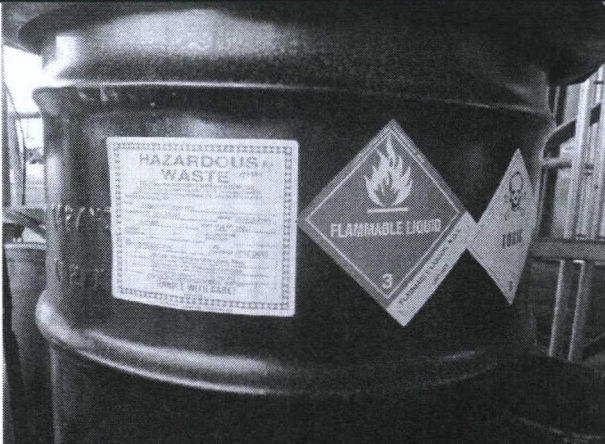
labeled as hazardous F032, D001 waste and bore flammable, toxic, and corrosive risk labels (Photos 3, 4, 5). This drum is moved to the 90-day accumulation area when full. Drip pads are rinsed using a garden hose following removal of debris. Process water from washing, plus drips from the pad, collects in the retort pans and is sent through oil/water separators and carbon filtration (water) or filter presses (oil) prior to re-use. Mr. Hillery stated that the facility does not utilize a boot wash to clean boots worn by operators working in the retort area or on the drip pad. I expressed to him that boots could be tracking hazardous materials from the drip pad to the control room located in the attached building, or elsewhere around the site. He said he was researching boot wash options when we arrived for our inspection that day.

Area & Description	Photographs
<p>#4 Retort Area</p> <p>Close-up of satellite 55-gallon drum located near retort.</p>

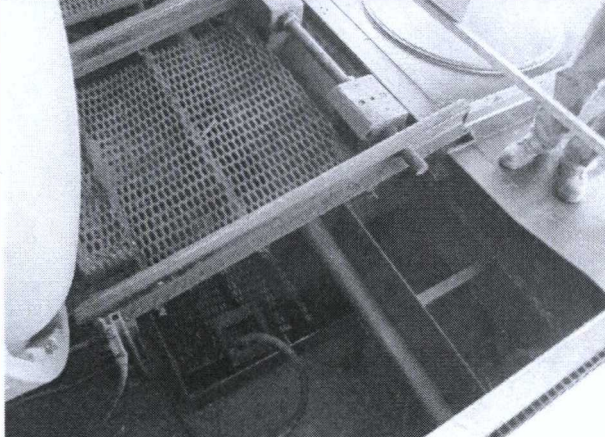
<p>#6 Retort Area</p> <p>Photo depicts drip pan located under north end of retort. This pan collects all drips of oily water. This water is re-used in the process. Both retort set-ups are identical.</p>

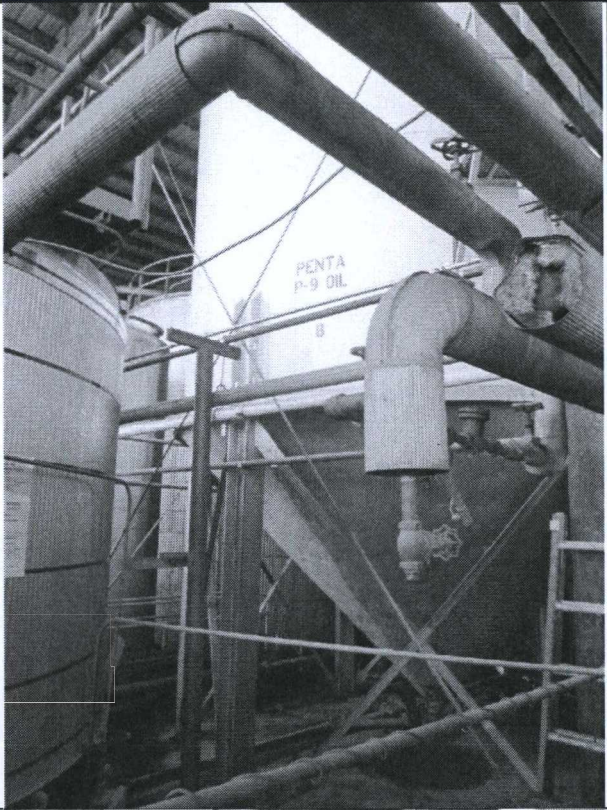
Area & Description	Photographs
<p data-bbox="126 314 321 346">#7 Retort Area</p> <p data-bbox="126 385 695 453">This photo shows one of several tanks holding pentachlorophenol oil product.</p>

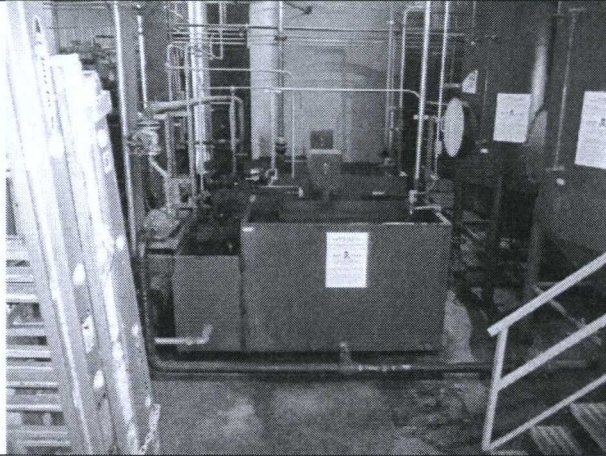
Area & Description	Photographs
<p>#9 Retort Area</p> <p>Oil-water separators for process water recycling and re-use.</p>

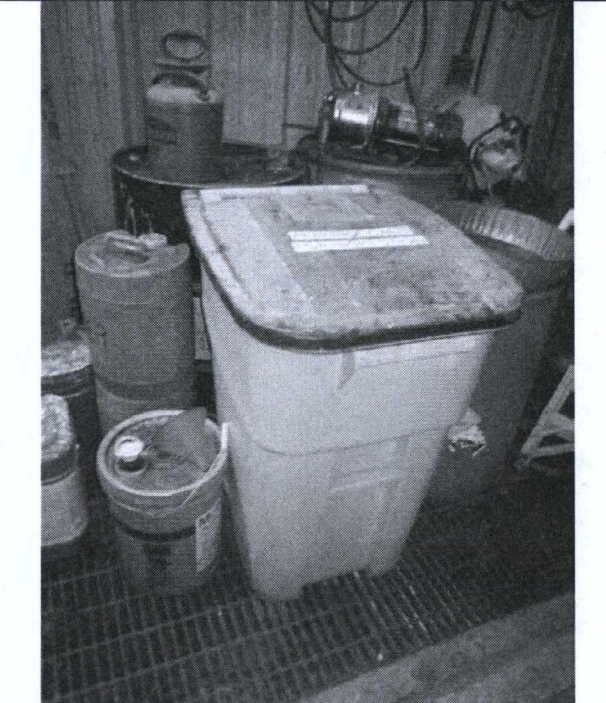
<p>#10 Product Storage Area in "Wash Room"</p> <p>The yellow tote in this picture contains used aerosol cans that are punctured near the used oil shed, and then transferred to this tote for off-site recycling.</p>

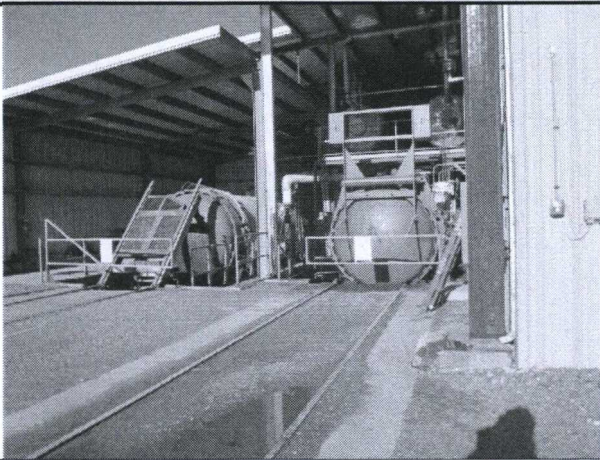
Area & Description	Photographs
<p>#11 Retort Area</p> <p>Southern end of retort area where charges are loaded into the blue tubes.</p>

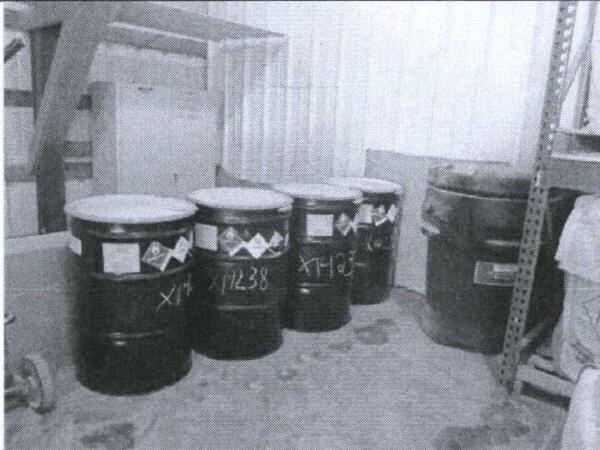
<p>#12 Waste Accumulation Area</p> <p>During the time of this inspection, the accumulation area held these four drums of the petroleum distillate oil with pentachlorophenol. Twenty-two drums of this waste had been shipped in the prior week.</p>

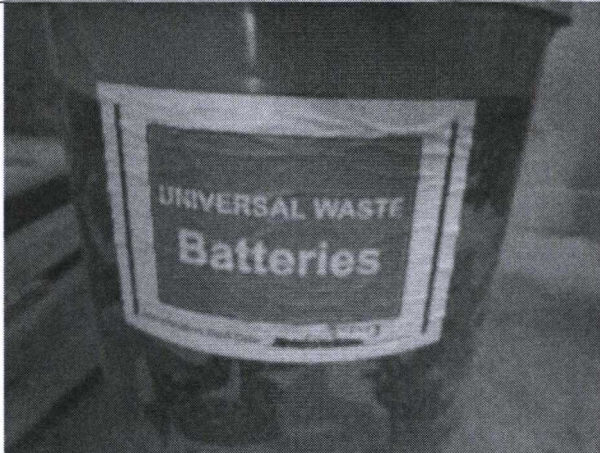
During the inspection I noted batteries and fluorescent lamps over their threshold time limits and asked Mr. Hillery to ship them off as quickly as possible. On February 16, Mr. Hillery emailed a scanned copy of a manifest showing the Universal Waste had been shipped offsite on February 4, 2015.

<p>#13 Waste Accumulation Area</p> <p>This drum of universal waste batteries shows a date (8-1-13) over the one year time limit for holding on site.</p>

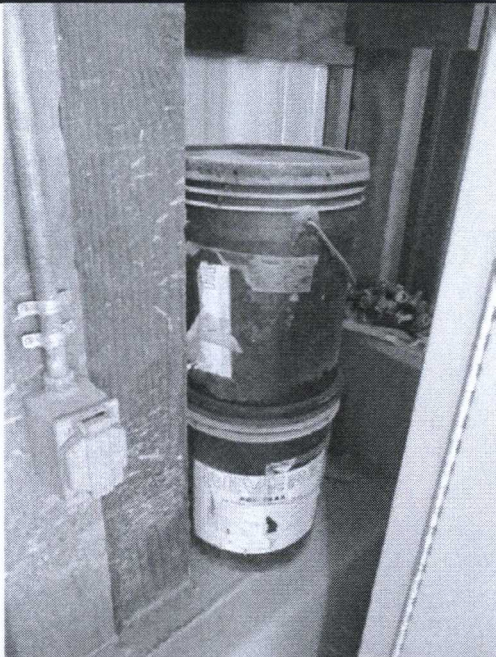
in the corner of this room (Photo 14). Mr. Hillery stated that these were product.

Area & Description	Photographs
<p>#14 Waste Accumulation Area</p> <p>These two 5-gallon buckets contained Revere Por Crax (SE corner of the waste accumulation room) an asphaltic sealer. It was stored here to prevent it from mistakenly being used in another application.</p>

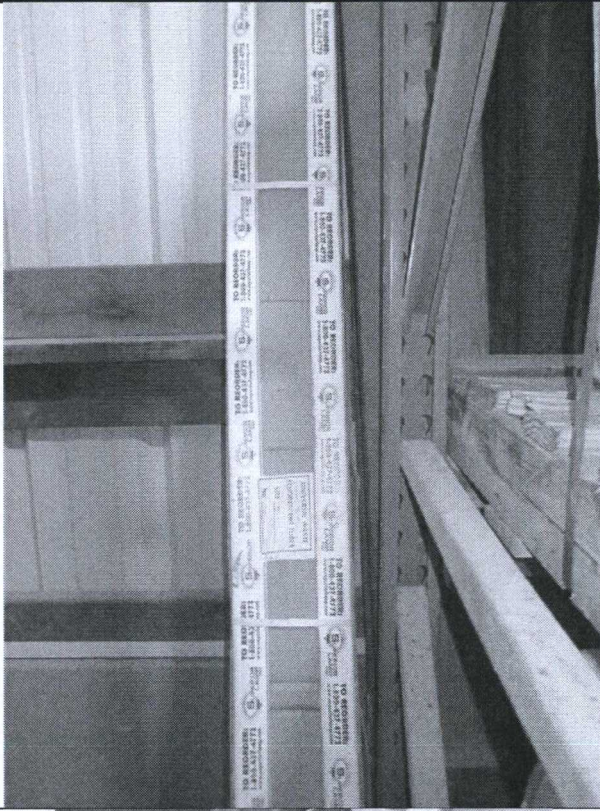
Area & Description	Photographs
<p>#16 Waste Accumulation Area</p> <p>A start date of 12/4/2013 was written on this box of Universal Waste lamps indicating the box is over the one year time limit (also shown in photo 15).</p>

- Store them in a closed container so that they will not be broken.
- Label their container with the words "Universal Waste-Lamps," or "Waste Lamps," or "Used Lamps."
- Include the start date when the first item was placed in the container to ensure recycling takes place within the 12-month accumulation time limit.

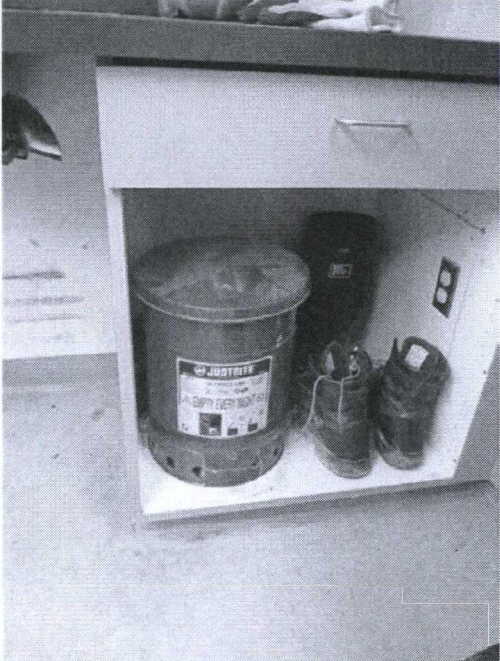
We then walked over to the laboratory, accompanied by Mr. Hillery. No employees were present (lunch time). Mr. Hillery showed us the two x-ray machines used to measure wood penetration (concentration of preservative in wood plugs removed from treated poles). Wooden cores and rags are placed in a red step-can that is emptied daily (Photo 17.) This can is not labeled with hazardous waste or risk labels.

<p>#17 Quality Control Laboratory</p> <p>This red step-can contains wooden core samples and used rags. This can is carried to the satellite accumulation area and emptied daily. The step-can lacked risk labels.</p>

Empty the red step-can containing used rags and wood cores into the appropriate satellite accumulation drum daily, or at the end of each shift (photo 17). It is recommended that this can have a label describing the major risk associated with the waste.

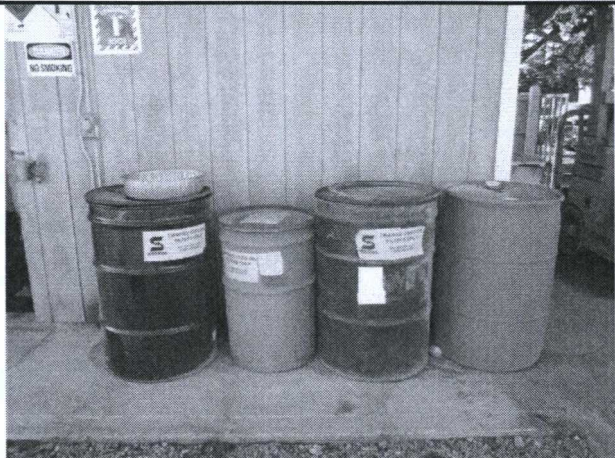
515(6)(a)(i)	<p>An open pan of used oil was found on top of a drum containing used oil filters (Photos 18 and 23).</p> <p>WAC 173-303-515(6)(a)(i): Containers of used oil must be kept closed except to add or remove used oil.</p>	Transfer used oil immediately into used oil collection drums. Close drum when not in use. Close tanks when filters have ceased dripping, or at the end of each day.
515(6)	<p>A pan of used oil found on top of a drum containing used oil filters lacked a "used oil" label (Photos 18 and 23).</p> <p>WAC 173-303-515(6) and by reference 40 CFR Part 279.22(c)(1): Containers and aboveground tanks used to store used oil at generator facilities must be labeled or marked clearly with the words "Used Oil."</p>	Label all used oil collection containers with the words "Used Oil." Photograph the properly labeled container(s) and include the photo when you return the enclosed Compliance Certificate.

Area & Description	Photographs
<p>#18 Oil Area</p> <p>The first three drums from the left contain drained oil filters and the blue drum on the far right contains spent hydraulic fluids.</p> <p>Note the oil pan on top of the first drum from the left. It was found to contain used oil but is open and unlabeled. See photo #23 for a better view of the pan. Used oil is collected in a tank within the building.</p>

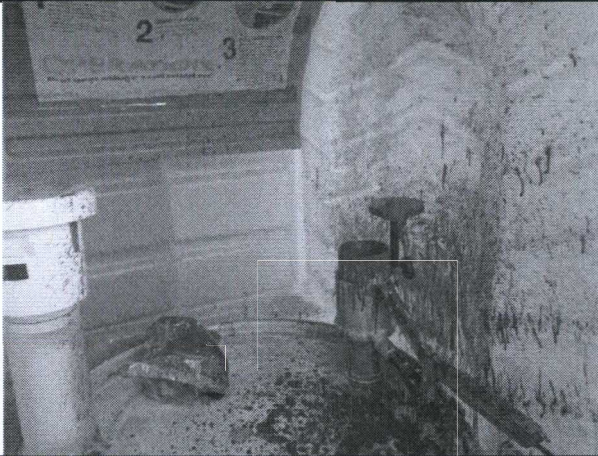
Area & Description	Photographs
<p>#21 Aerosol Can Puncturing Area</p> <p>The unit is located on the north side of the oil area.</p>

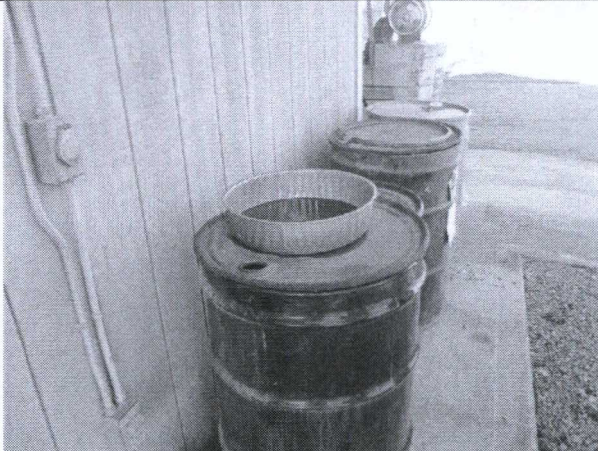
<p>#23 Oil Area</p> <p>Open, unlabeled container of used oil found on top of one drained oil filter drum.</p>
